TOWN OF GOLDEN BEACH

OCTOBER 2019 HIGH TIDE EVALUATION REPORT

OCTOBER 8, 2019

CRAIG A. SMITH & ASSOCIATES
21045 Commercial Trail
Boca Raton, Florida 33486
561.314.4445

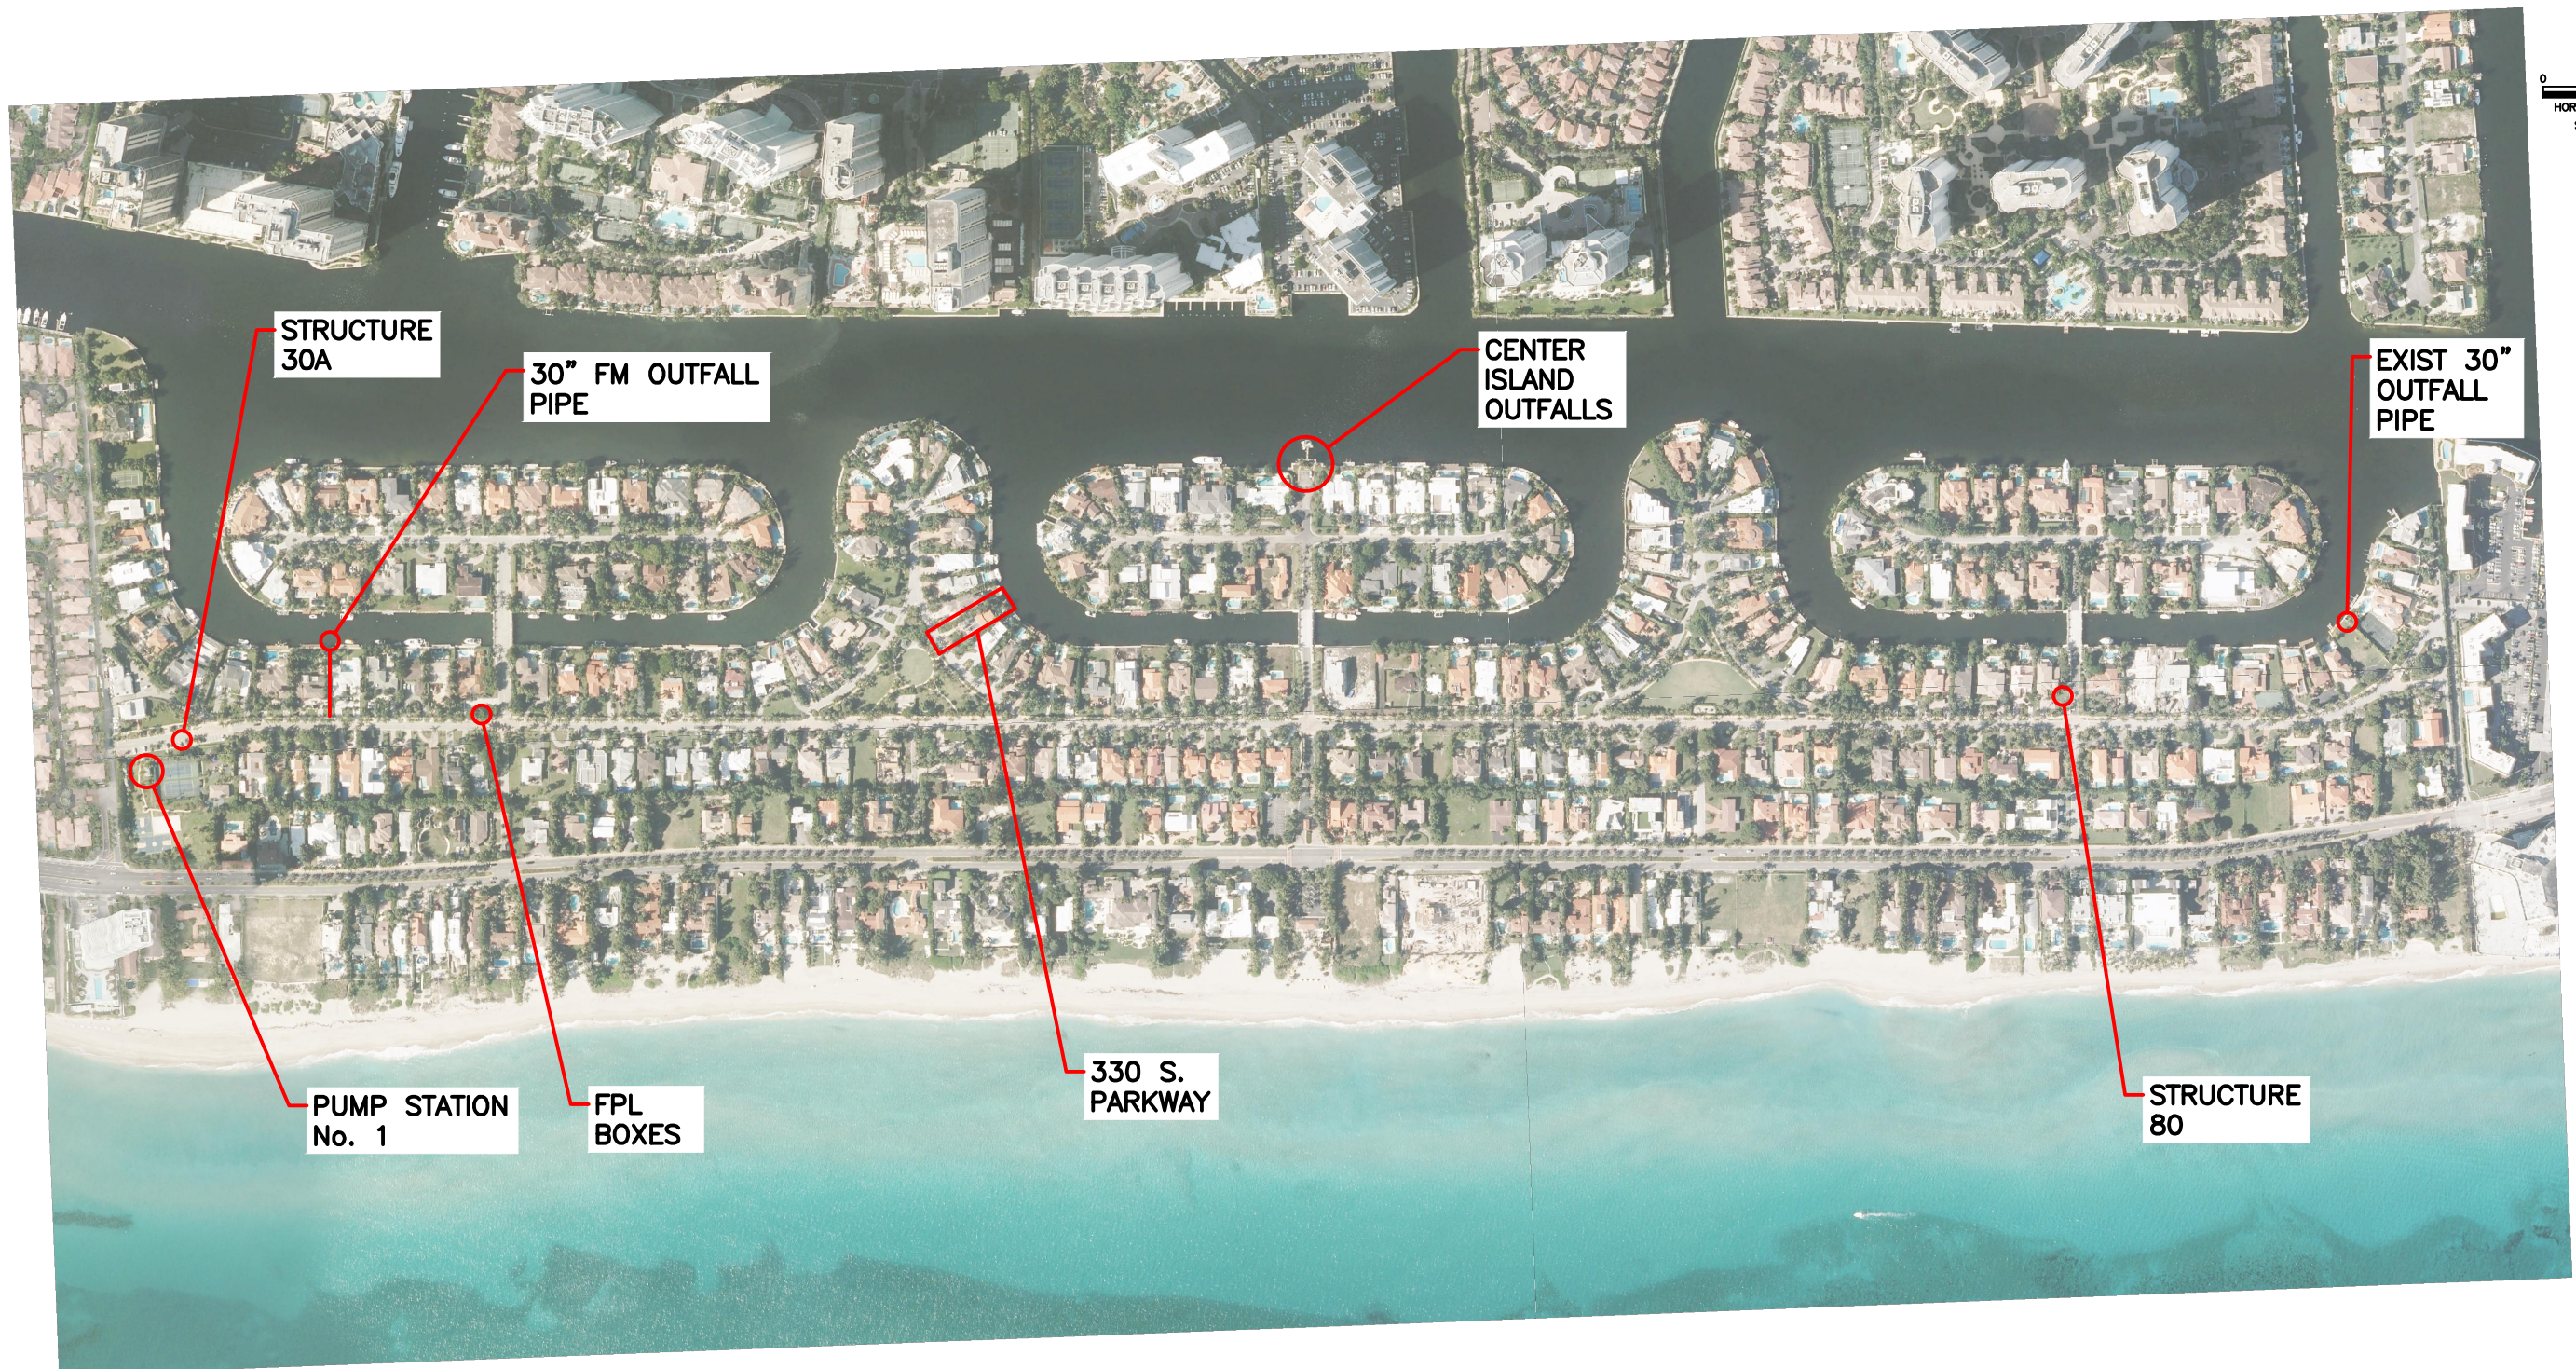
EXHIBIT D

water was observed entering the east side of structure number 30A (Exhibit D), across from town hall. This was caused by a failure in the integrity of the sealing of the top slab to the walls of the structure.

- CAS recommends that Structure 30A, located near Tweddle Park, be properly sealed to prevent groundwater intrusion. To sufficiently repair this structure, it will require that the existing concrete flume be removed, and replaced, in order to seal both the inside and outside of the structure. The estimated cost for this work is \$3,000.
- During construction of the Town's Capital Improvement Project new Florida Power and Light and Bell South Utility handholes and pull boxes were installed under the current west sidewalk when all utilities were placed underground. There is little that can be done to eliminate Intracoastal water infiltration and create a water-tight seal on the utility boxes and vaults.

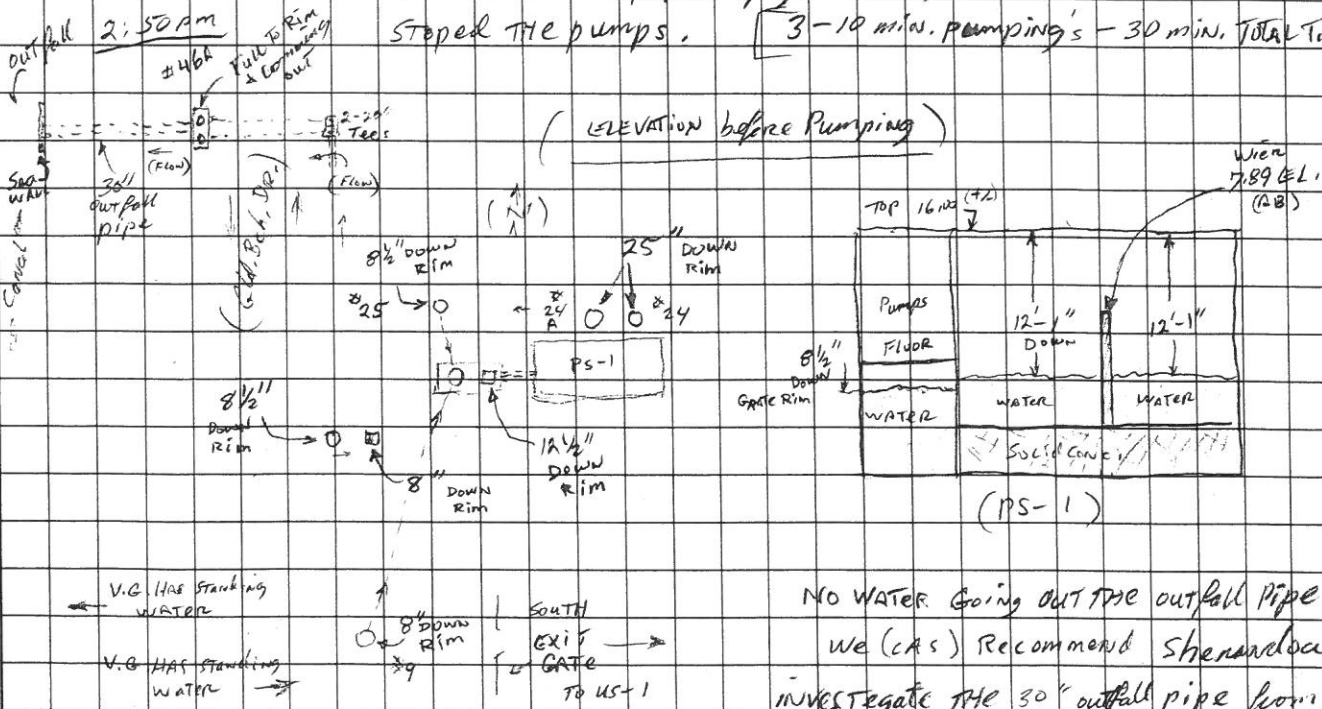
2:15 pm City Turned on the pump (#1).
 Water took 37 sec's, to build up and spill over the weir wall and another 38-40 sec's, to come out of the 2-m.H. Lids at #46 A (Flooding the yard, sidewalk & street), NO water coming out of the outfall pipe from #46A.

Replaced the lids on #46A and the 2-m.H. Lids "24 & 24 A" at the P.S. "popped-up", Flooding the Tennis Courts, Stopped the pumps. [3-10 min. pumping's - 30 min. total time]

NO WATER GOING OUT THE outfall Pipe.
 We (CAS) Recommend Shenandoa T.V. Truck investigate the 30" outfall pipe from the #46A structure to the sea wall outfall end for blockage &/or any damages.

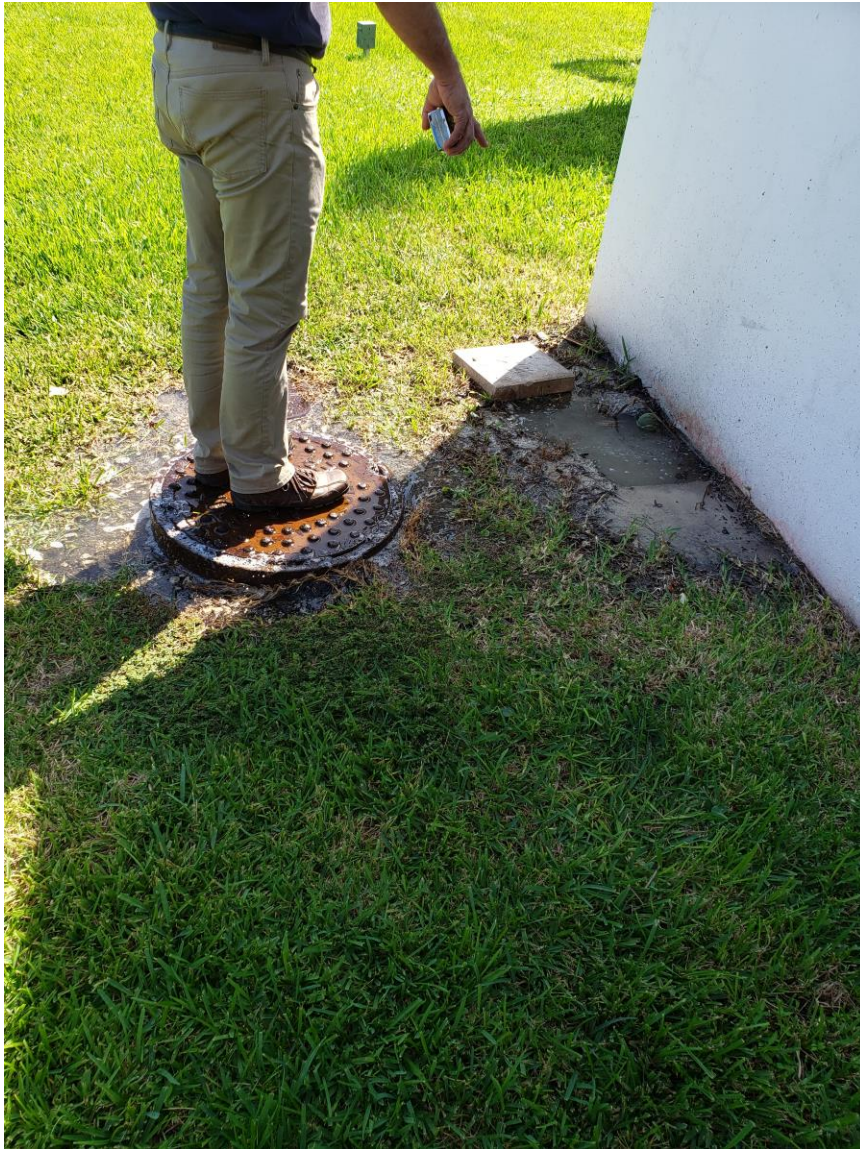
- CAS and Town staff investigated an exfiltration issue at the Tweddle Park pump station. When the pumps at the station were initiated, a surge of water was forced out of the manhole covers at the well discharge pipe on the north side of the pump station. A second inspection was performed on Thursday, October 3, 2019 to determine the exact cause of the issue also observed the possibility of leakage from the north face of the existing pump station weir chamber (Refer to Exhibit E – Observation Report). Through a series of tests on the entire outfall pipe it was determined that the surge issue was back pressure caused by the extreme high tide. Refer to Exhibit D and photograph 1 in Exhibit F.
- King high tides also inhibit drainage well performance where discharge can only occur during higher elevations due to the mounding effect caused by density differential between fresh and saltwater.

Photo 1 : (10-1-19) Manhole covers for stormwater force main at Pump Station No. 1.

- After observing the surge conditions at the pump station, CAS coordinated with Shenandoah Construction to have the pipe televised and cleaned as necessary. Since no new obstruction in the outfall pipe was discovered, CAS concluded that the surge issue was due to back pressure caused by king high tides. CAS recommends that the existing stormwater pump station and the entire gravity outfall pipe (from the pump station to the sea wall) be evaluated to determine the feasibility of replacing or converting this pipe run with a pressure pipe. If the feasibility analyses support the tidal surge acting against the discharge through an actual force main, CAS will recommend the replacement of the stormwater discharge wells and convert the existing gravity outfall to a force main discharge.

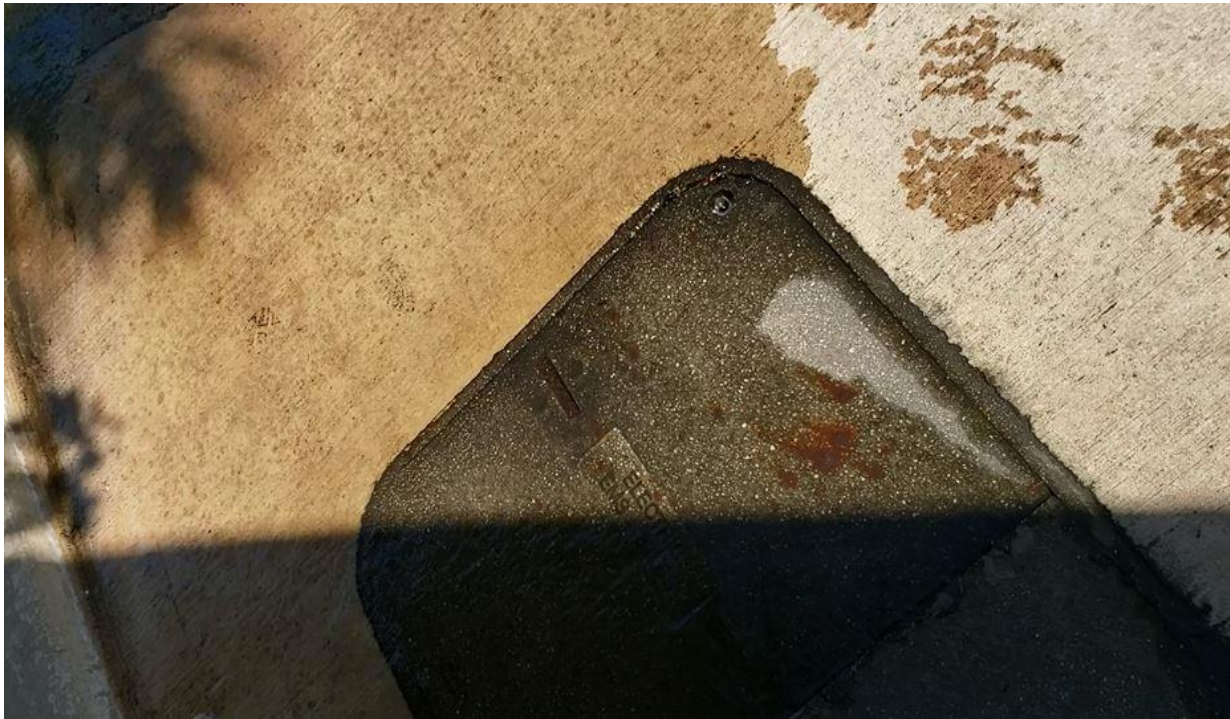
- Intracoastal water was also observed discharging from a group of Florida Power and Light handhole covers located in the sidewalk at the southwest corner of Golden Beach Drive and Verona Avenue. (Exhibit F, Photo 2)
- At 330 South Parkway Intracoastal water was observed seeping out at the lots lowest point; where the concrete drive connected with the front green area. This property is one of the oldest developed lots in the area, constructed in 1946, and has existing lot grades ranging from 2.8 to 3.4 NGVD. (Exhibit F, Photo 3)

When the tidal water/Intracoastal water reaches an elevation higher than existing ground levels, that water eventually seeps through the soil and migrates into the yards and streets as demonstrated in Exhibit F, photos 2 and 3. In areas where this occurs, the water will remain until the tide recedes.

Photo 2: (10-1-19) Tidal Seepage at FPL Electric Box.

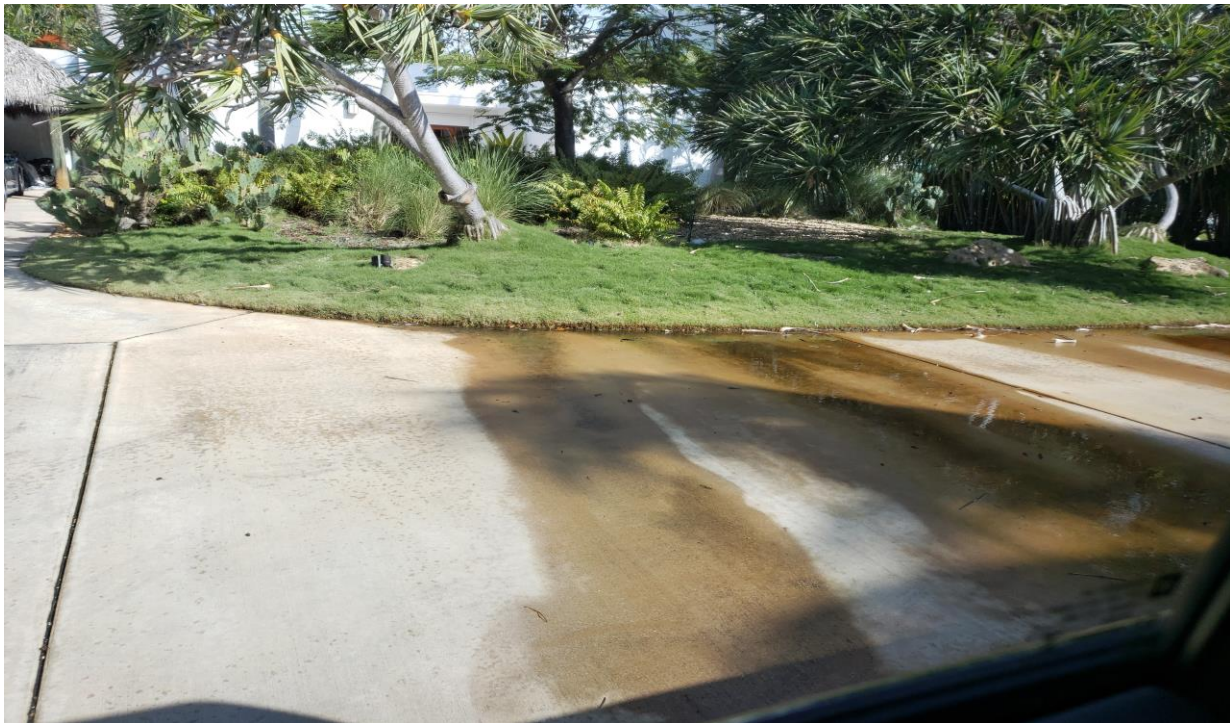
Photo 3: (10-1-19) Tidal seepage at 330 South Parkway.
